Fall 2007
Vol. 3, No. 2

STRUCTURE & SITE

Updates & Information from Klepper, Hahn & Hyatt

Local Landmarks Benefit from Building Envelope Expertise

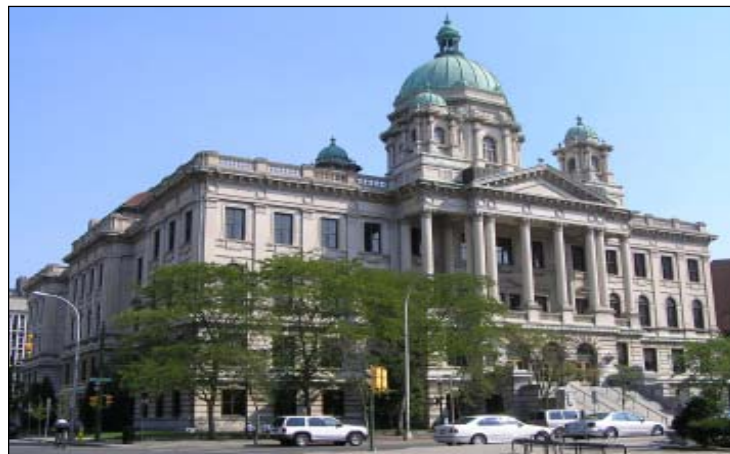
The 1907 Onondaga County Court House

Like Crouse College, the Onondaga County Court House was designed by renowned architect Archimedes Russell. The Court House, which opened January 1, 1907, was unique for the incorporation of a built-in vacuum sweeping system, concealed wiring and telephone lines, and five hydraulic elevators. The building was listed on the National Register of Historic Places in 1980 as part of the Montgomery Street-Columbus Circle Historic District.

While the Board of Directors originally wanted to clad the building in granite, replicating the appearance of the Albany Capitol building, they compromised for the sake of economy. The upper portion of the building is sheathed in Indiana Buff Ooletic limestone from Bedford, Indiana. Limestone could be cut and carved by machine without handwork. More expensive Gray Granite was used for the base, entry stairs and platforms.

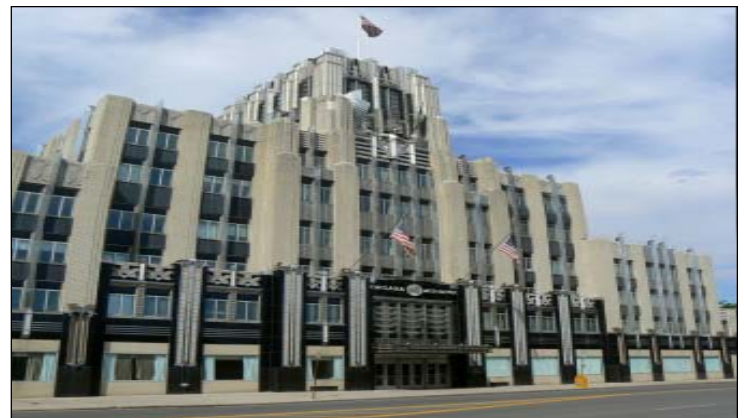
The NiMo Building, constructed in 1932

The NiMo Building is notable architecturally for its innovative design and massing, inventive use of materials such as cast stone, terra cotta, aluminum cladding, Vitrolite, molded glass, stainless steel (called CN or chrome nickel steel) and neon/helium exterior lighting, plus its overall futuristic appearance. It was planned as both an office building and a showroom and promotion center for electric power.

Among the remediation items that will be undertaken by the KHH team is the replacement of a majority of the roofs. There are 20 separate roofed areas comprising a total of approximately 20,000 square feet. For the facade restoration, the list of priority items includes replacing deteriorated cast stone elements, removal and replacement of coping

stones to allow installation of proper flashings, repairing deteriorated sections of parapet walls, and removing all caulking, sealants, and older repair materials which prevent moisture from escaping from the walls. National Grid has also elected to replace all the windows with historic replications to provide more energy efficient units as well as restore the original appearance to the building. In all, the work is expected to require about two years to complete.

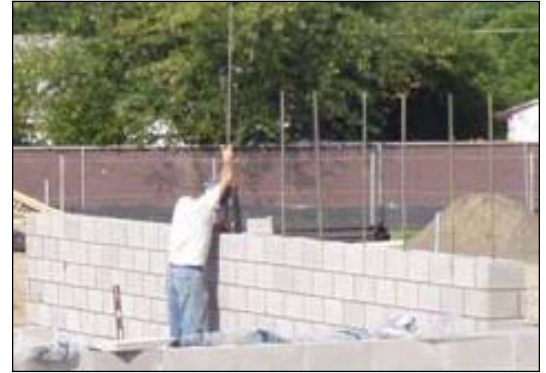
Threading rebar positioners for low-lift grouting

- **Excessive grout pour heights**
Low-lift grout pours can be up to five feet high. High lift grouting, which requires cleanouts in the face shells at the base, can be up to 24 feet high, but may be limited by grout penetration, bar length and tie spacing, and length of the vibrator.
- **Inadequate positioning of vertical reinforcing bars**
We specify bars be secured at least 200 bar diameters on center, and at splices. This means that for low-lift grouting, vertical bar positioners into which the bars can be threaded down after erection and PRIOR to grout placement, can be no more than 4'-8" on center. With high-lift grouting, the long bars can be inserted after wall erection and tied at the cleanouts at the base of each pour. In all cases, the

splice length of the bar should extend above the top of the grout pour.

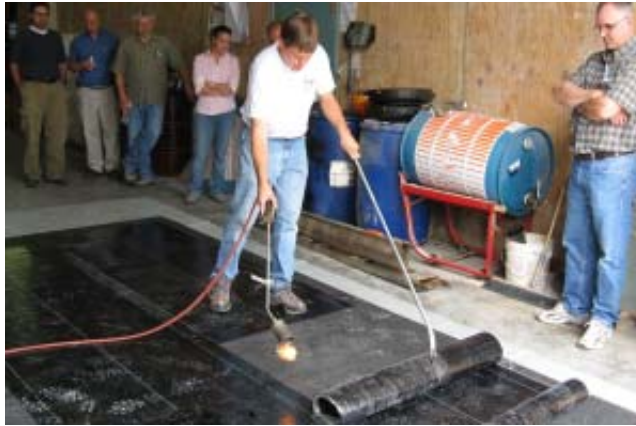
Jamie Trevvett, left, practices an application of torch applied roofing during the Roofing Workshop at the Henderson Johnson facility on Canal Street in Syracuse. Watching him at right is Richard Colson, a project manager at Bell & Spina Architects. Below, Janice Medina, Jamie Trevvett and Neil Garry, P.E., apply liquid roofing onto reinforcing felts on a roofing mockup.

A Roofing Workshop held at Henderson Johnson Company was co-sponsored by Soprema, a roofing manufacturer, and CNA Associates. Participants learned about both liquid applied roofing and torch applied (modified bitumen) roofing, working on test applications of each type to experience working with the product.

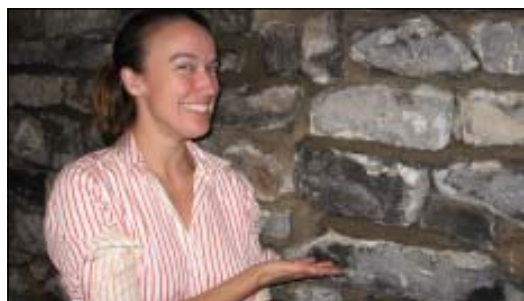
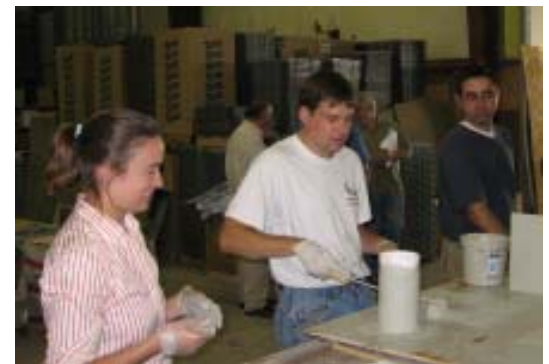
A Masonry Workshop sponsored by Driscoll Masonry taught both designers and masons how to properly install natural cement. Ken Uracius of Masonry Restoration in Holden, Massachusetts, conducted the workshop. As part of their understanding of natural cement, which is a softer mortar, participants learned about natural cement products, their history and the process to develop them, and their uses and applications. They mixed burnt lime, called quick lime, in test dishes to make lime putty, experimenting with its properties and consistency, and then used some of it to point a masonry wall.

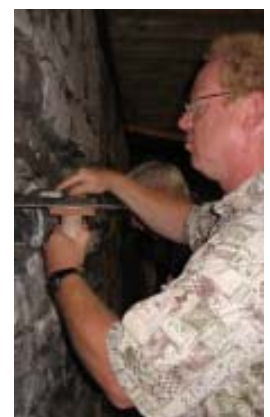
Janice Medina, left, shows an area of wall to which she applied mortar during the Masonry Workshop in Skaneateles Falls. Rich Applebaum, right, carefully practices his pointing skills with the natural cement.

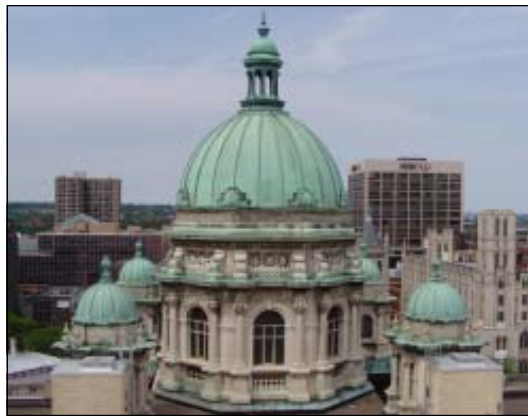
The main dome and satellite domes of the Onondaga County Court House prior to the start of roofing work.

The roofing restoration presents some singular challenges in the variability and types of roofing, according to Toby Nadel, A.I.A. Mr. Nadel is the manager of the KHH Building Envelope Systems Division and has decades of roofing experience. The Court House roof consists of four elevator towers, five copper domes (one large central dome and four smaller satellite domes) and two "very unusual" clay tile domes.

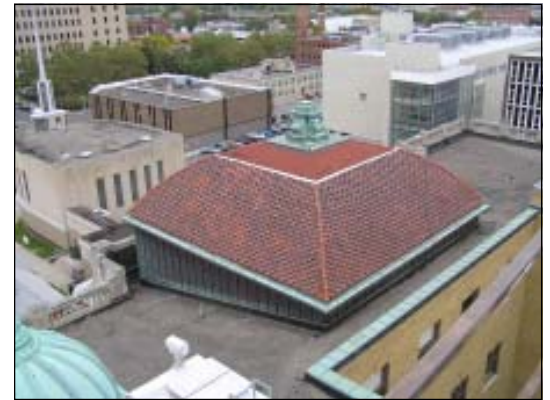
View of the north clay tile dome on the roof of the Onondaga County Court House.

A brief search uncovered the original molds for the clay tile roofing, which were manufactured by Ludowici-Celadon, originally of Alfred, New York, now located in Chicago. The tiles will be re-manufactured for the new roof application.

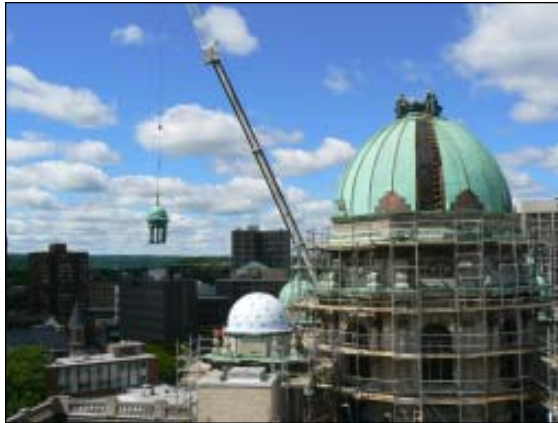
As work begins on the court house roof, the cupola is removed from the main dome.

The cupola has been removed from the main dome, and the domes have been cloaked in a self-adhering membrane that is considered a full roof in itself. The membrane protects the dome elements for the duration until the building is re-clad in copper.

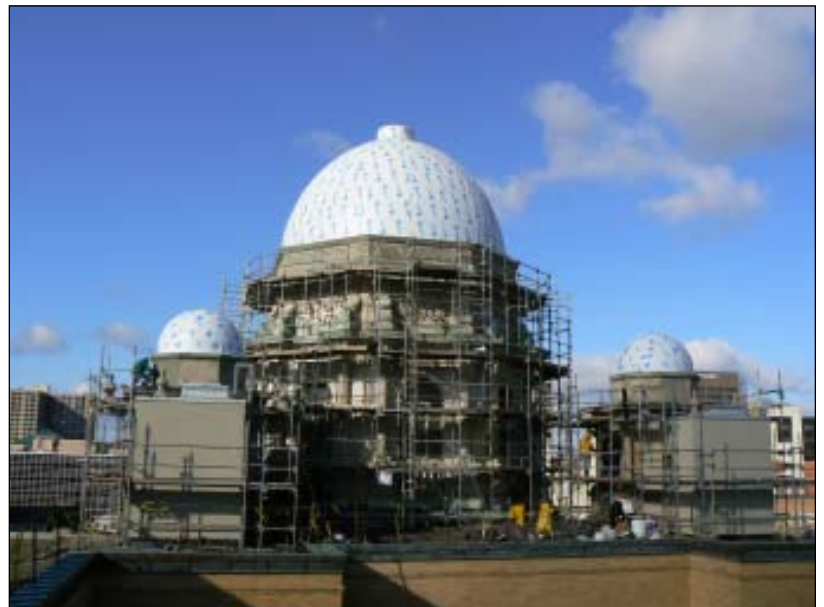
The court house domes are clad in protective self-adhering membranes until they are ready to be re-covered in new copper.
